# ADVANCED TURBINE TECHNOLOGY APPLICATIONS PROJECT (ATTAP) 1992 ANNUAL REPORT

Engineering Staff of  
Garrett Auxiliary Power Division  
A Unit of AlliedSignal Aerospace Company

March 1993

Prepared for  
NATIONAL AERONAUTICS AND SPACE  
ADMINISTRATION  
Lewis Research Center  
Cleveland, Ohio 44135  
Under Contract DEN3-335

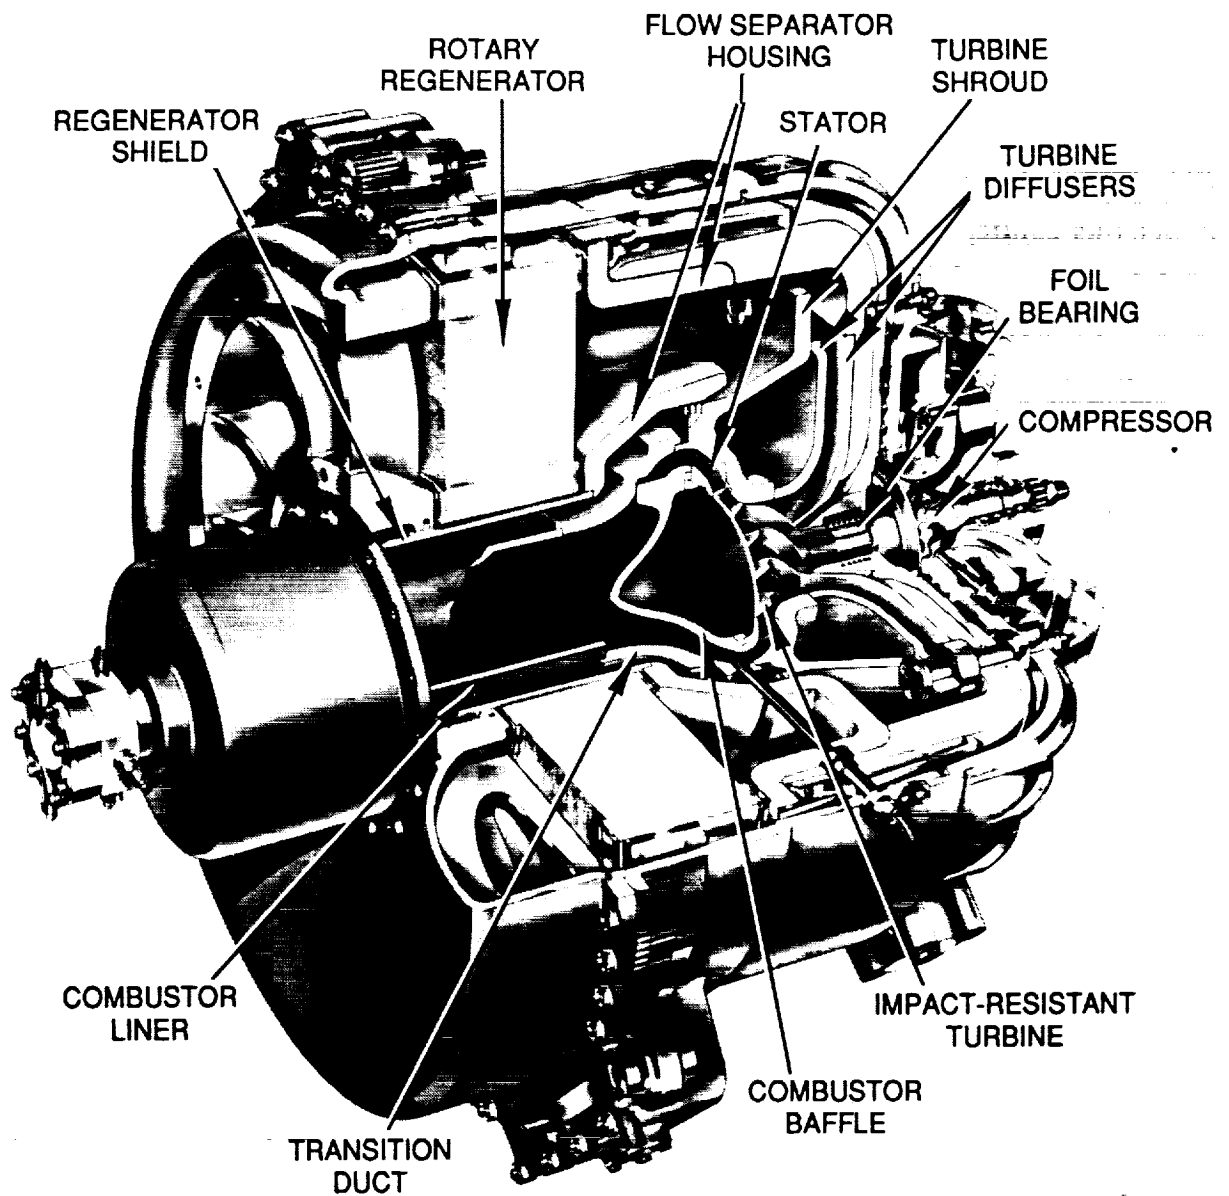
GB8071(05)-1

**Figure 1. Garrett Model AGT101 ATTAP Test Bed Engine.**

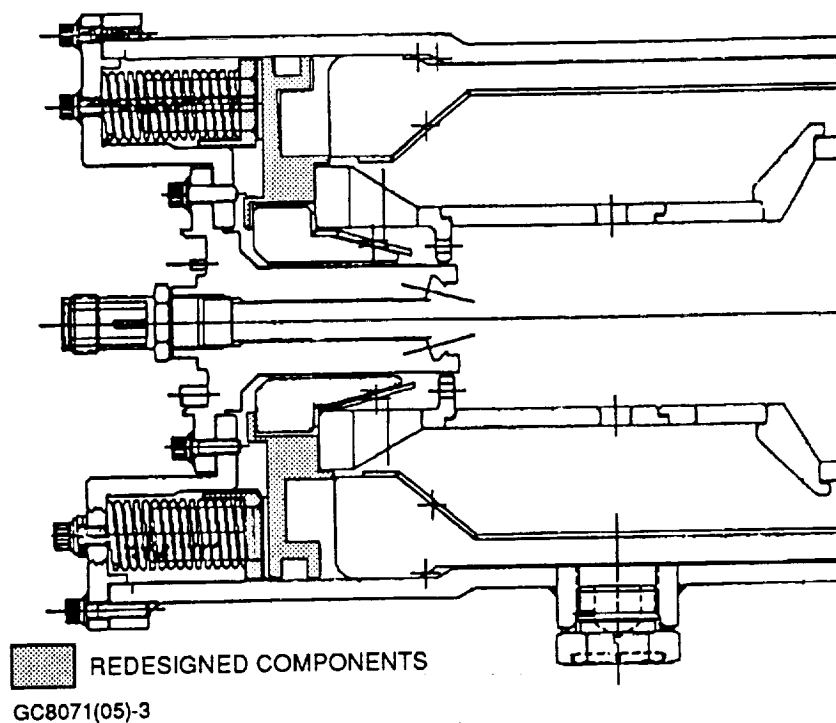
**Figure 3. New Combustor Cap Design Lowers Spring Operating Temperature.**

The combustor cap spring configuration (Figure 3) was designed to keep the combustor load springs cool throughout the range of engine operation. Prior regenerator rig tests showed spring operating temperatures ranged up to 1300F (704C), which is above the acceptable operating level for the spring material. The springs apply the compressive load needed to maintain the ceramic combustor hardware stack and the seal of the flow separator housing seal rings. Operation at the elevated temperature causes the spring material to creep over an extended time period and lose its compressive load capability. Incorporation of the new design lowered the temperature of the springs to under 1000F (538C), which provides acceptable operation.

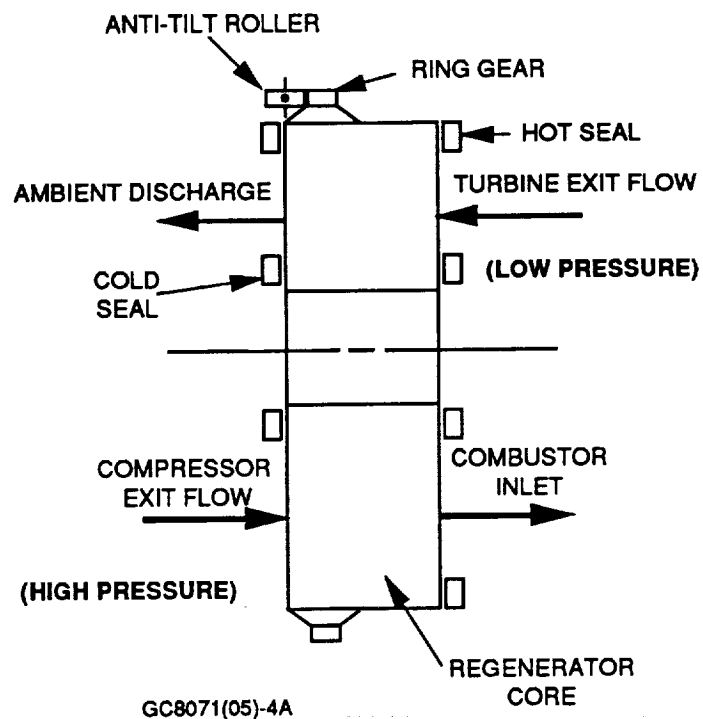
**Figure 4. Anti-Tilt Roller Design Reduces Seal Leakage And Regenerator Torque.**

The second design evaluated in the regenerator rig was the anti-tilt roller for the regenerator support system. Prior rig tests indicated displacement and tilting of the regenerator core occurred during engine operation. Measurements indicated a maximum deflection of 0.028 inch (0.072 cm) at the outer periphery of the core at maximum rig temperature and pressure. The regenerator core tilt increased the leakage across the face of the hot seal, and increased the load on the cold seal, causing an increase in the regenerator core torque. The anti-tilt roller (Figure 4) was designed to react the pressure forces of the airflow through the regenerator core ring gear, thus reducing the leakage and torque.

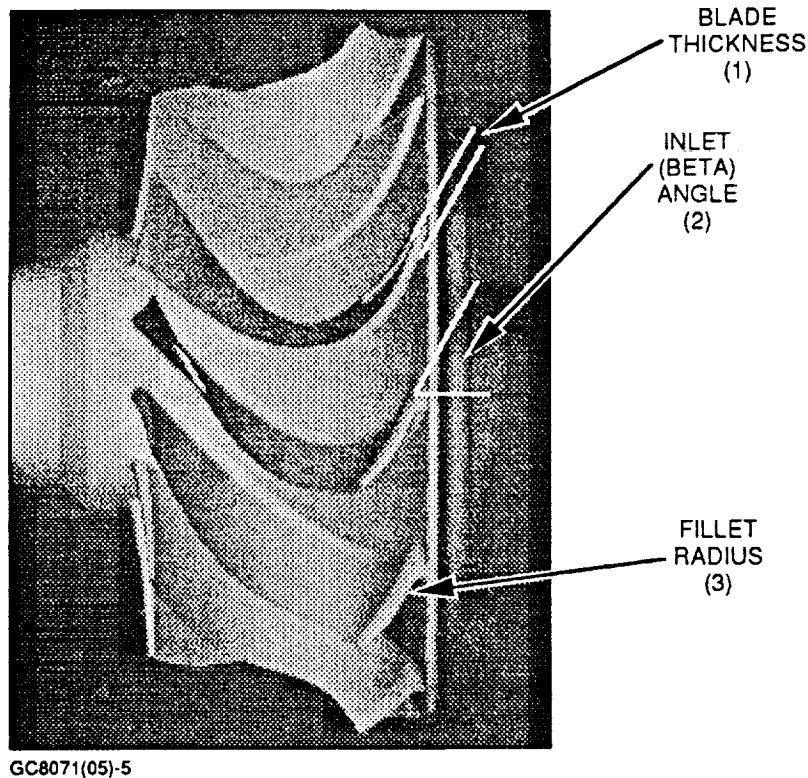
GC8071(05)-5

**Figure 5. Three Ceramic Blade Design Parameters Were Found To Have The Greatest Influence On Impact Resistance.**

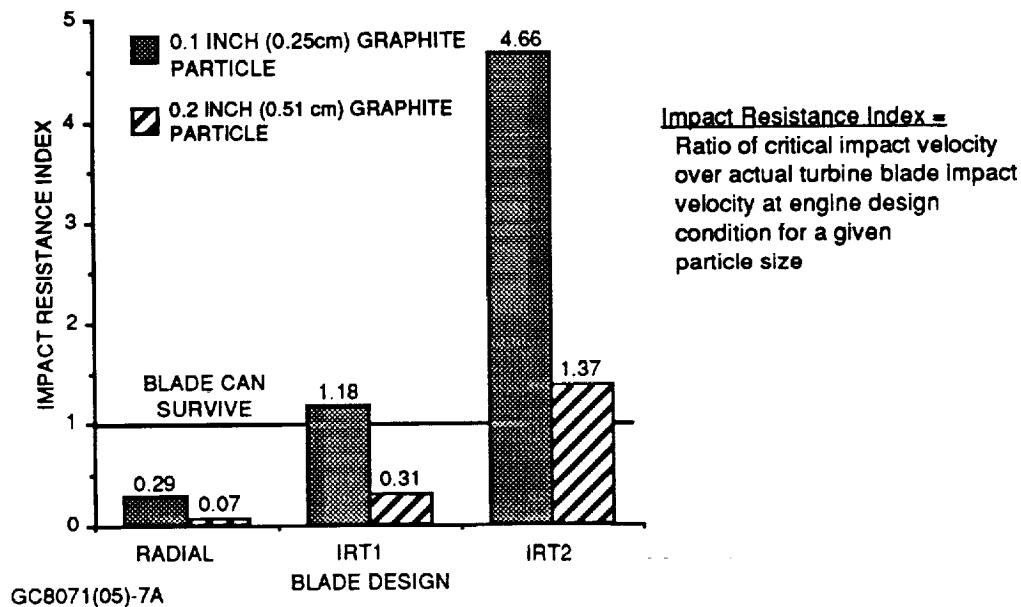
**Figure 7. IRI Plot Shows Significant Improvement In Impact Resistance Was Achieved With New Design Method.**

A more meaningful comparison of impact resistance for different blade designs employs the impact resistance index (IRI), defined as the ratio of the critical impact velocity for a particle impact divided by the actual turbine blade velocity at the engine design condition for a given particle size. The IRI values for the original AGT101 radial turbine blade, the current ATTAP IRT blade (Subelement 1), and the optimal IRT blade (Subelement 2) from the parametric study are shown in Figure 7. In the IRI plot, one unit corresponds to the threshold level at which a blade can survive for a particular particle size. A particle size of 0.20 inch (0.51 cm) is used to calculate this IRI index, because it is the largest particle able to pass through the stator opening of the AGT101 engine.

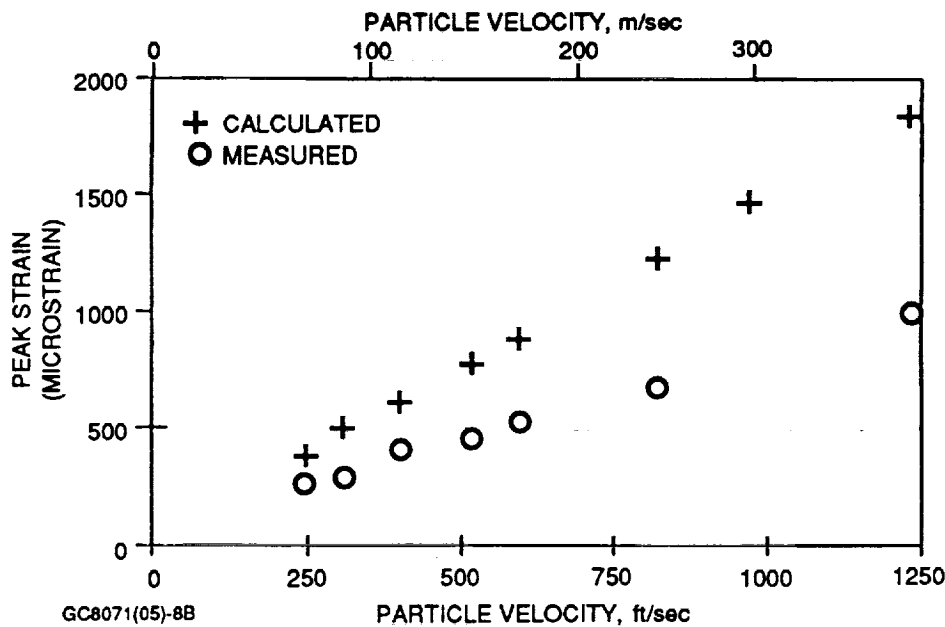
**Figure 8. Calculated Strains Using Elastic Model Are Much Higher Than The Measured Strains.**

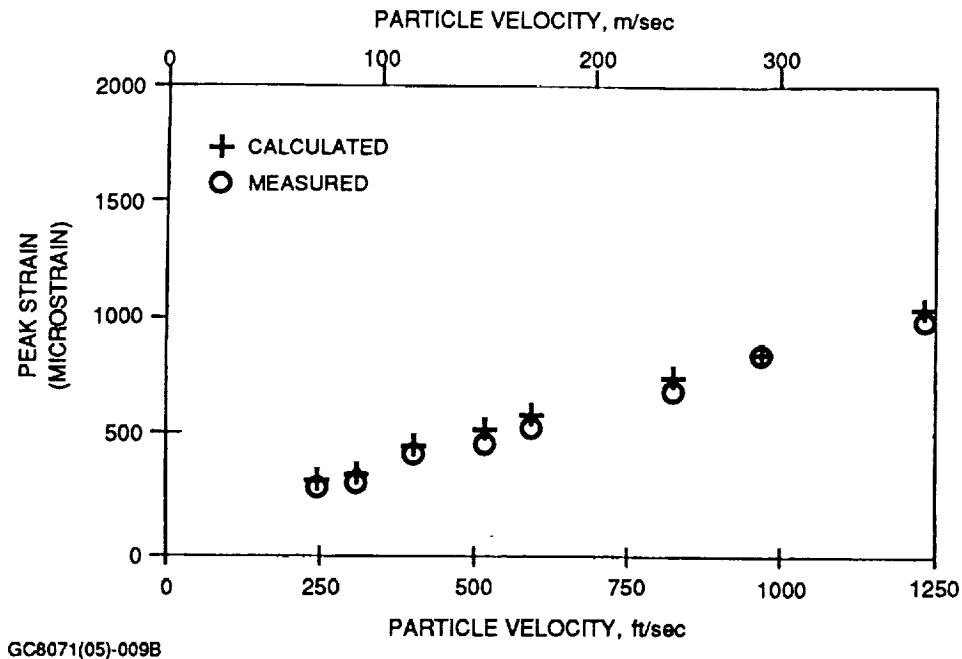
**Figure 9. Macromechanical Impact Model Produces Better Agreement Between Analytical And Experimental Results.**

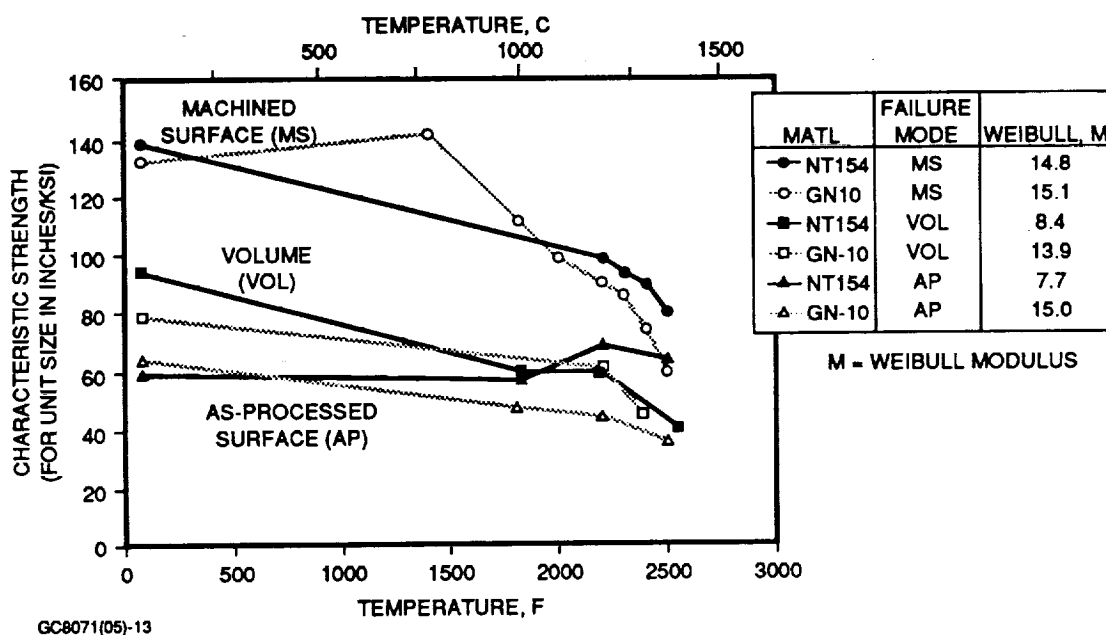
Figure 13. Weibull Parameters For NT154 And GN-10 Used In Rotor Failure Probability Analysis.

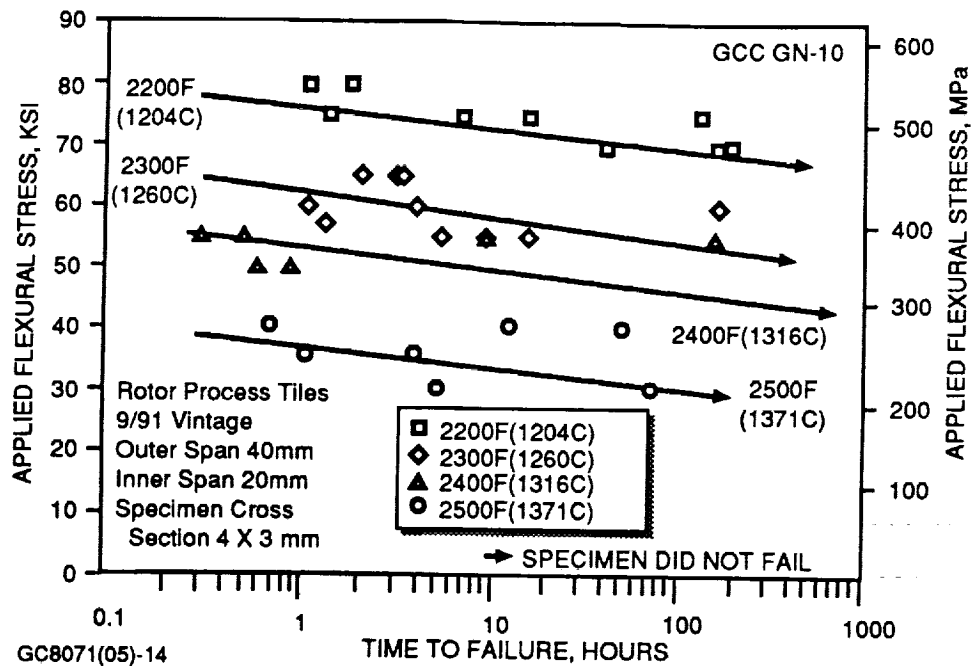
Figure 14. GN-10 Stress Rupture Data Used For Slow Crack Growth Predictions.

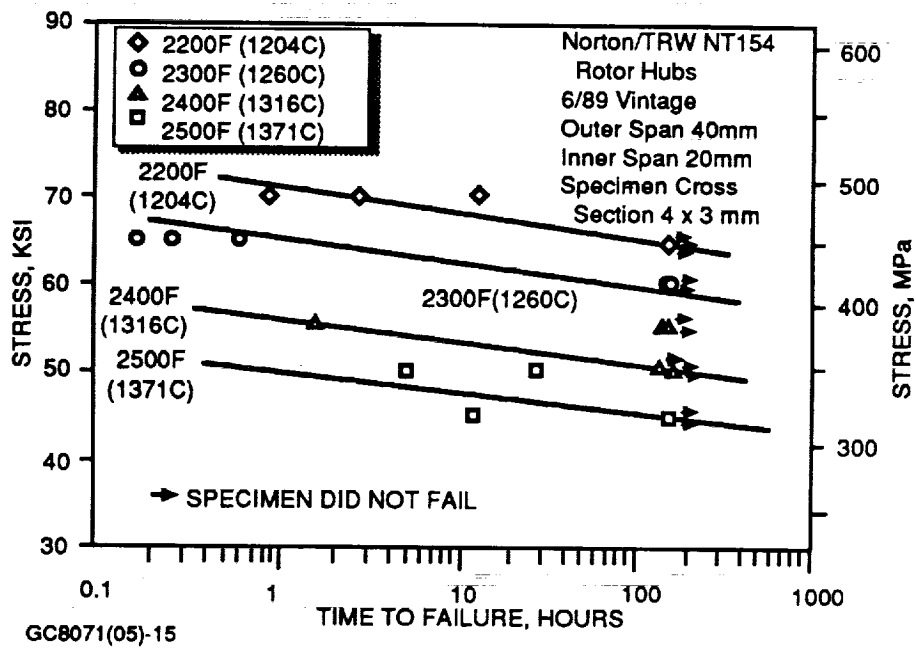
Figure 15. NT154 Stress Rupture Data Used For Slow Crack Growth Predictions.

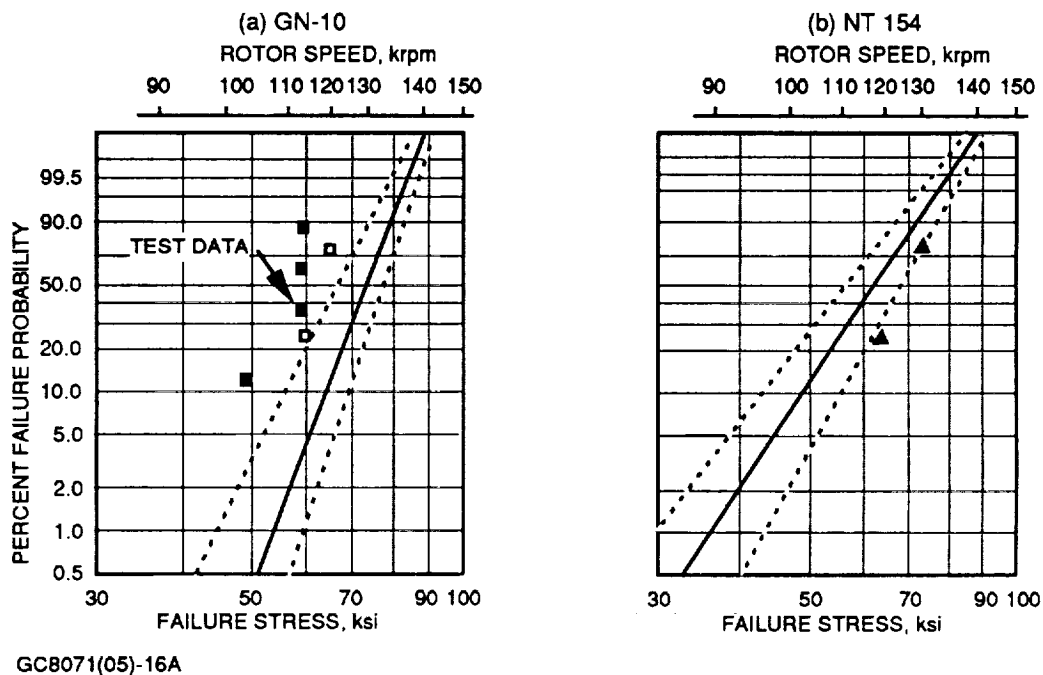
**Figure 16. GN-10 (Left Plot) And NT154 (Right Plot) Failure Predictions Compared With Spin Test Results.**

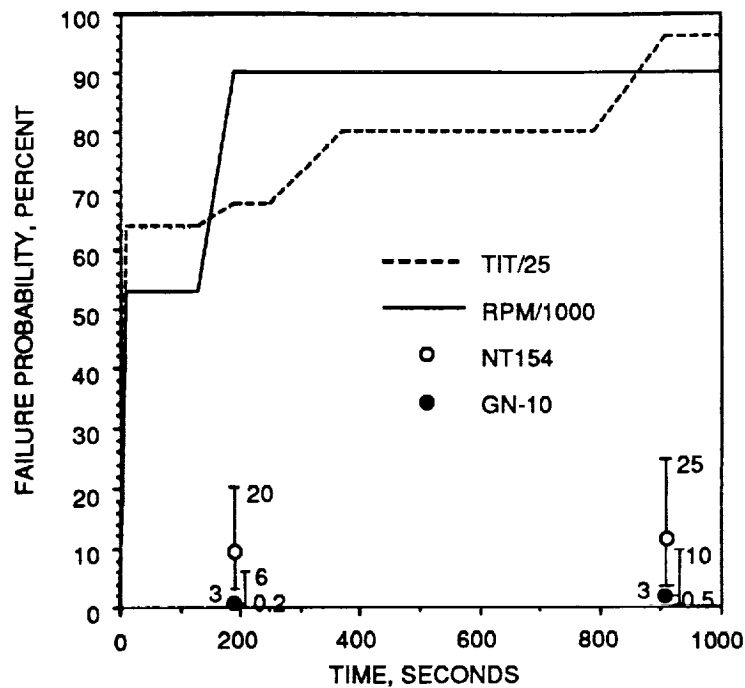
GC8071(05)-17

**Figure 17. Fast Fracture Life Prediction For ATTAP Milestone 5 Durability Cycle Testing .**

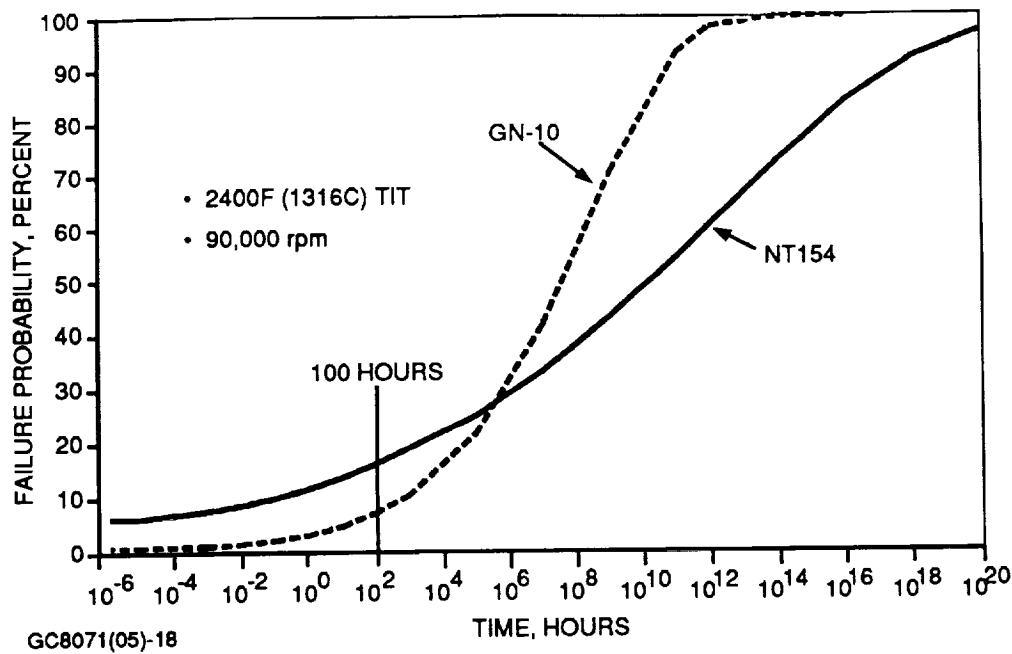
**Figure 18. Comparison Of NT154 And GN-10 Slow Crack Growth Lives At 2400F (1318C) TIT And 90,000 rpm.**

Slow crack growth (SCG) behavior was investigated for the AGT101 rotor at the steady-state operating conditions of 2404F (1318C) turbine inlet temperature (TIT) and 90,000 rpm. The prediction methodology so far cannot establish a measure of confidence for SCG, as has been done for FF. The SCG results for GN-10 and NT154 rotors are shown in Figure 18. Here again, GN-10 is predicted to be superior to NT154. This is attributed to the higher Weibull modulus of the GN-10.

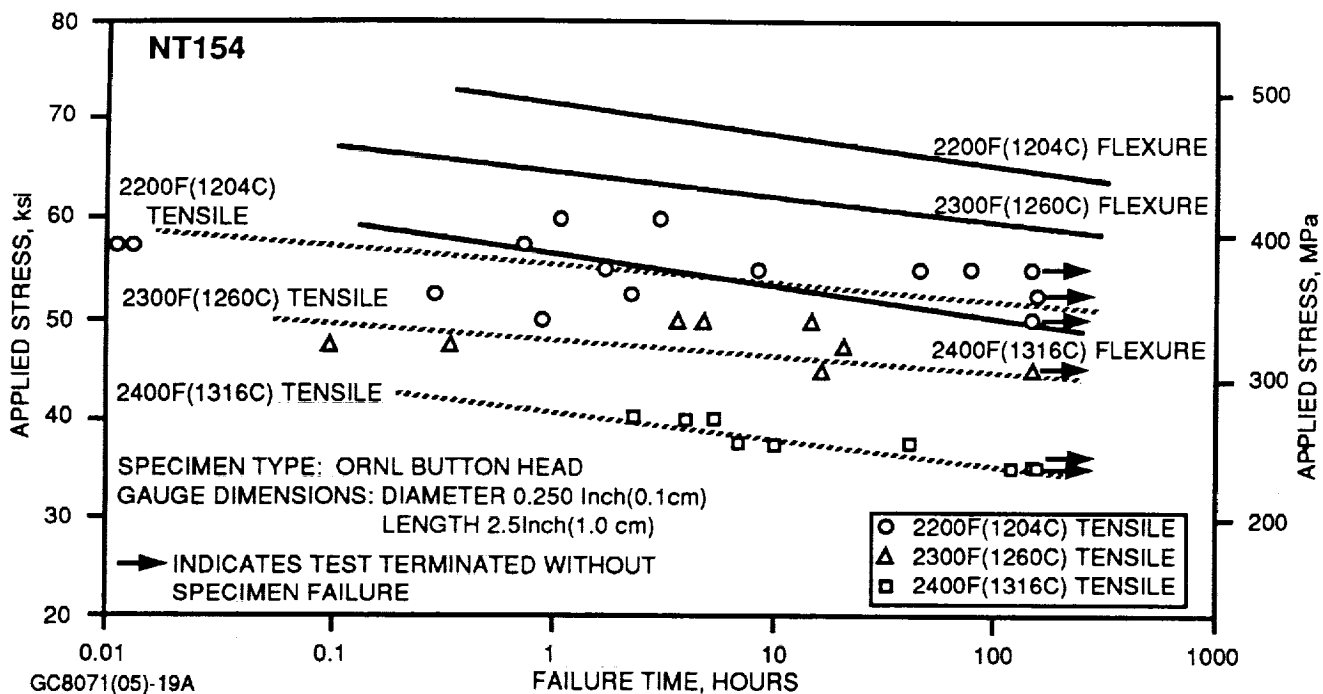
**Figure 19. Comparison Of NT154 Flexural And Tensile Stress Rupture Test Results.**

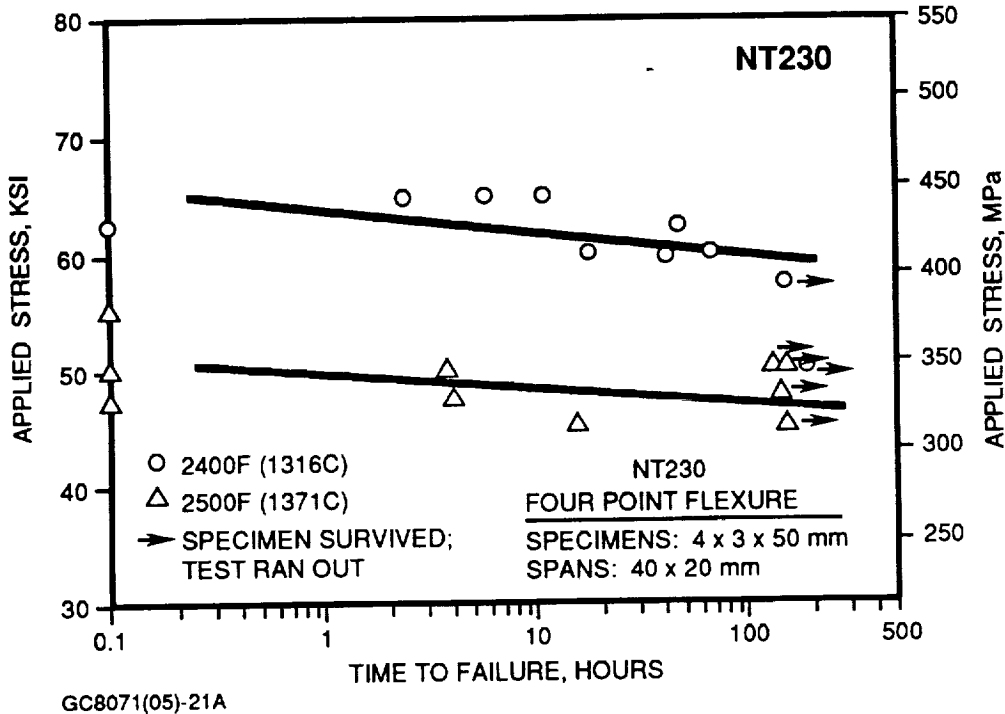
Figure 21. NT230 Flexural Stress Rupture Test Results.

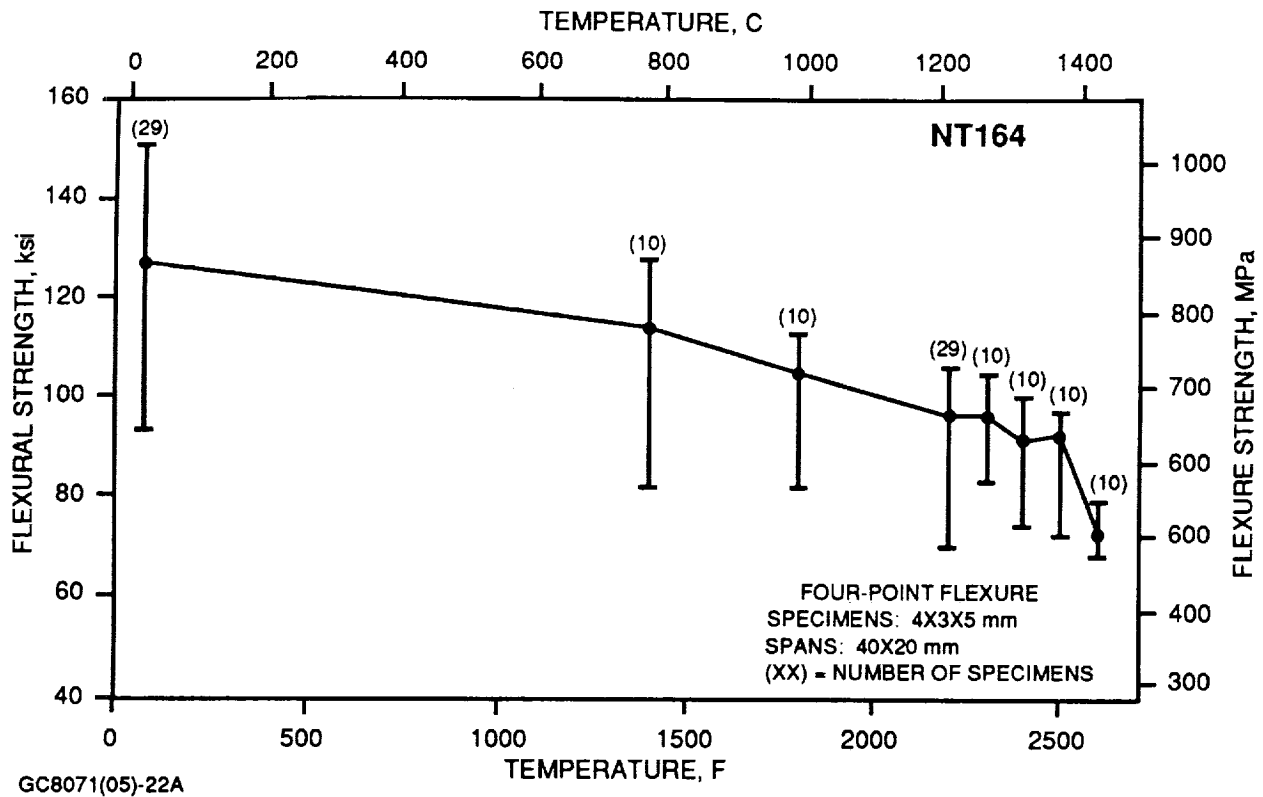
**Figure 22. NT164 Flexural Strength Test Results.**

Flexural strength testing of NT164 silicon nitride (pressure slip cast and HIPped) flexure test specimens was performed during 1992. The test results are plotted as a function of temperature in Figure 22.

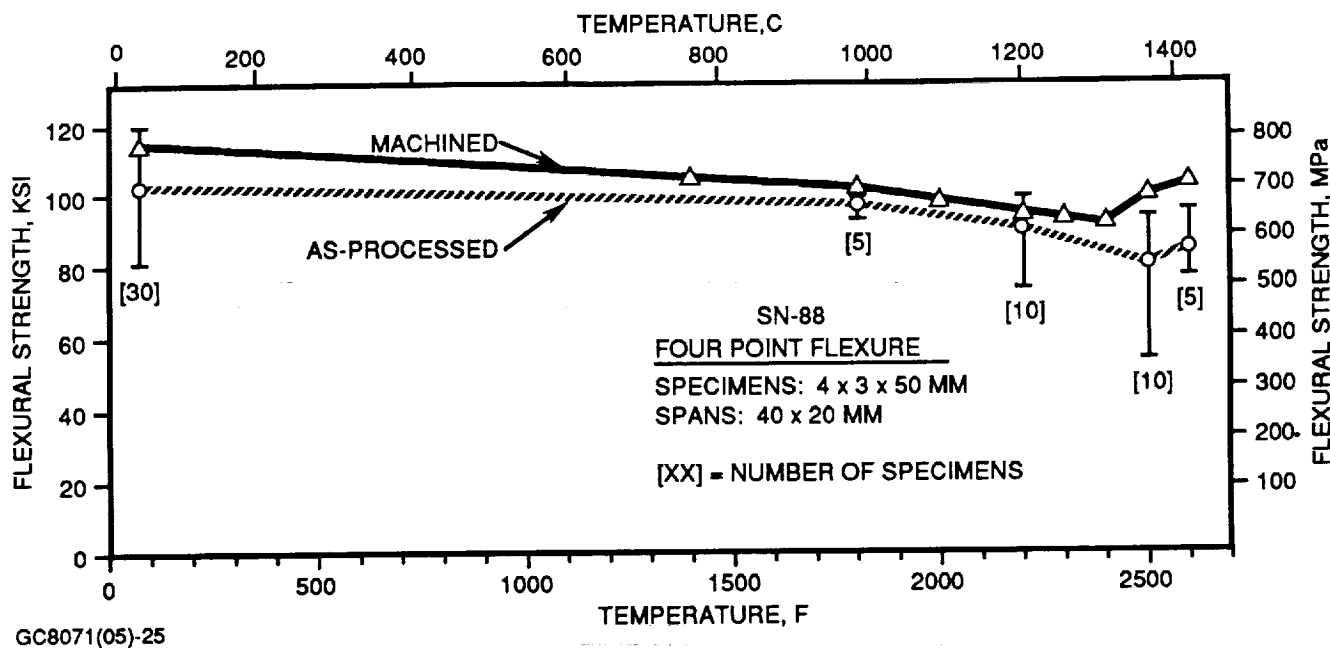
Figure 25. SN-88 Flexural Strength Test Results.

Flexural strength testing of NGK SN-88 silicon nitride (isopressed and green machined) flexure test specimens with the test surface left in the as-processed condition was performed. The as-processed and machined surface strength properties are plotted as a function of temperature in Figure 25 for comparison.

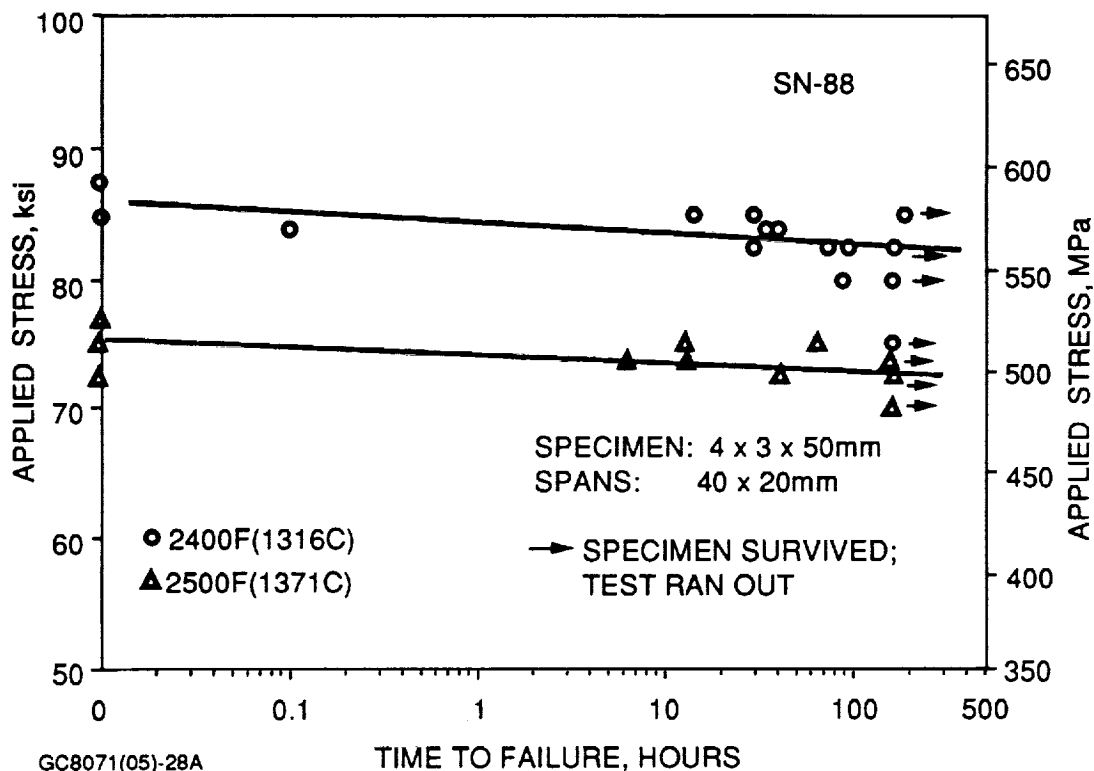
Figure 28. SN-88 High-Temperature Stress Rupture Test Results.

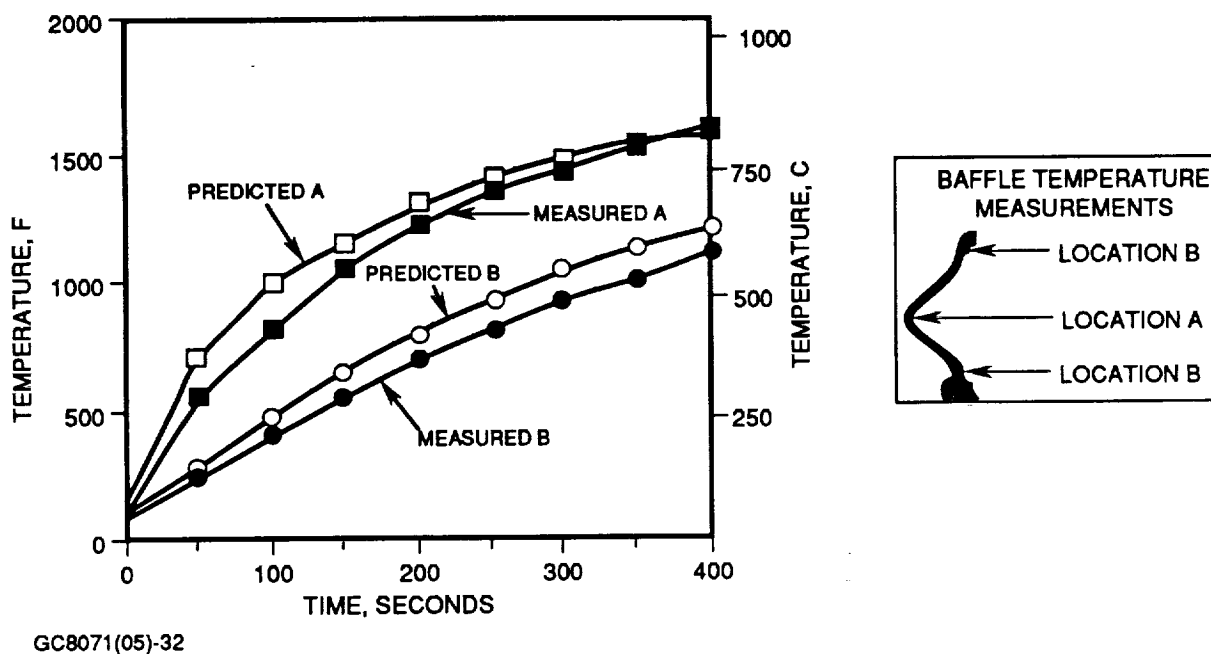
Figure 32. Component Thermal Proof Test Cycles Were Analytically Defined And Experimentally Verified.

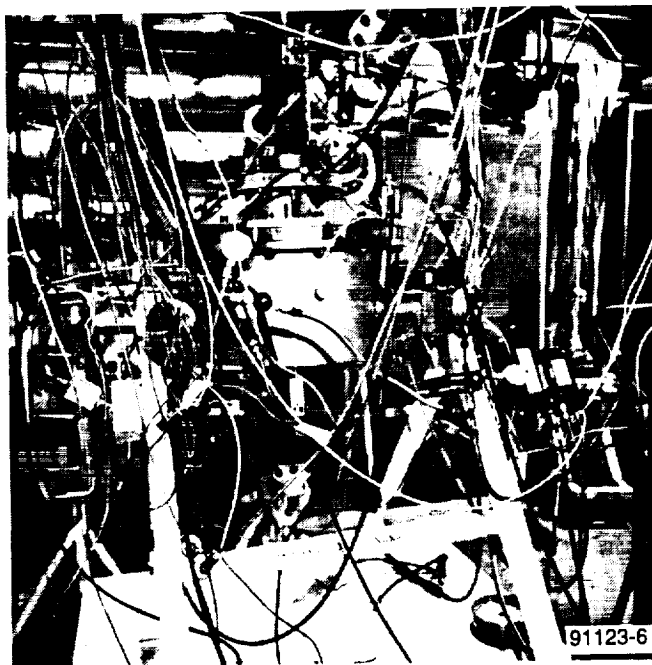
**Figure 35. The 2500F (1371C) Test Rig Exposes Ceramic Hardware To High Temperature To Verify Suitability For Engine Testing.**

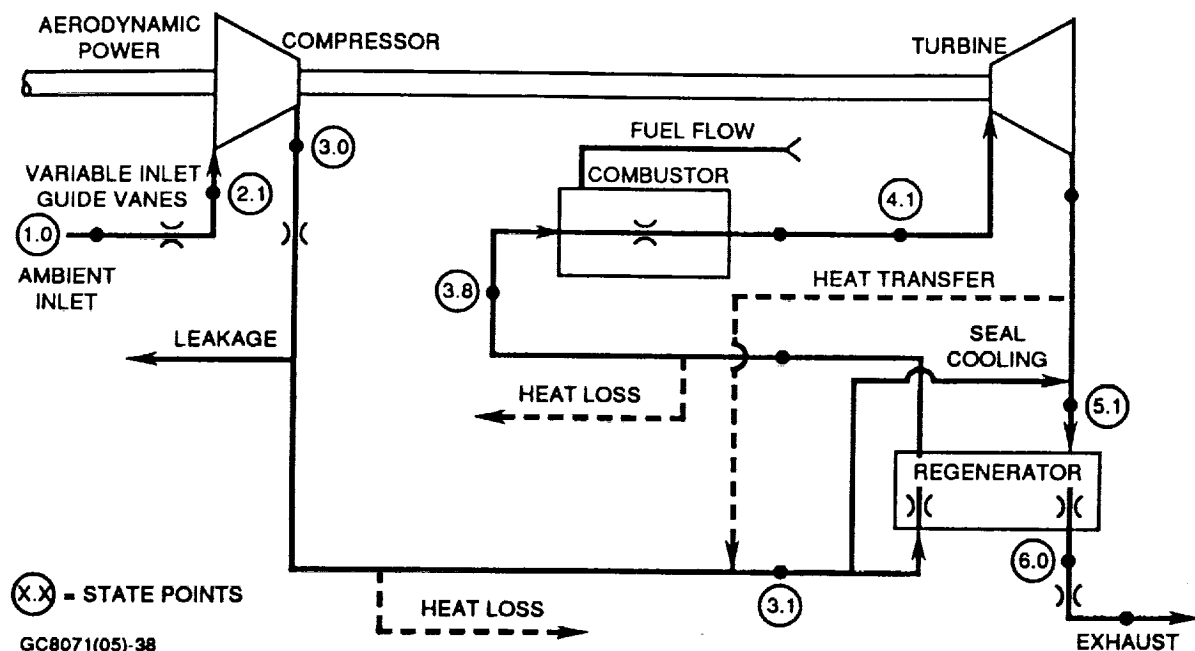
Figure 38. AGT101 Engine Cycle State Points.

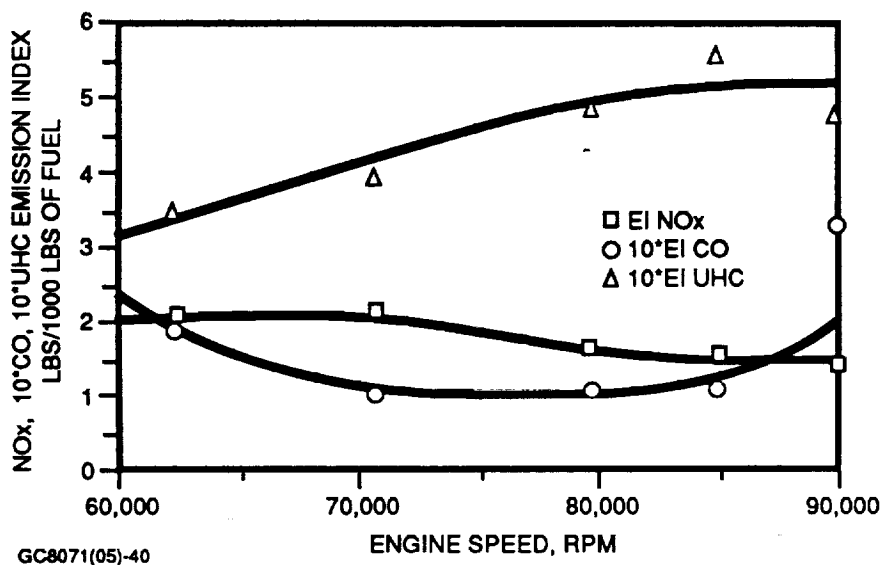
**Figure 40. Milestone 4 Emissions Index (EI) Versus Engine Speed (Commercial Ethanol Fuel).**

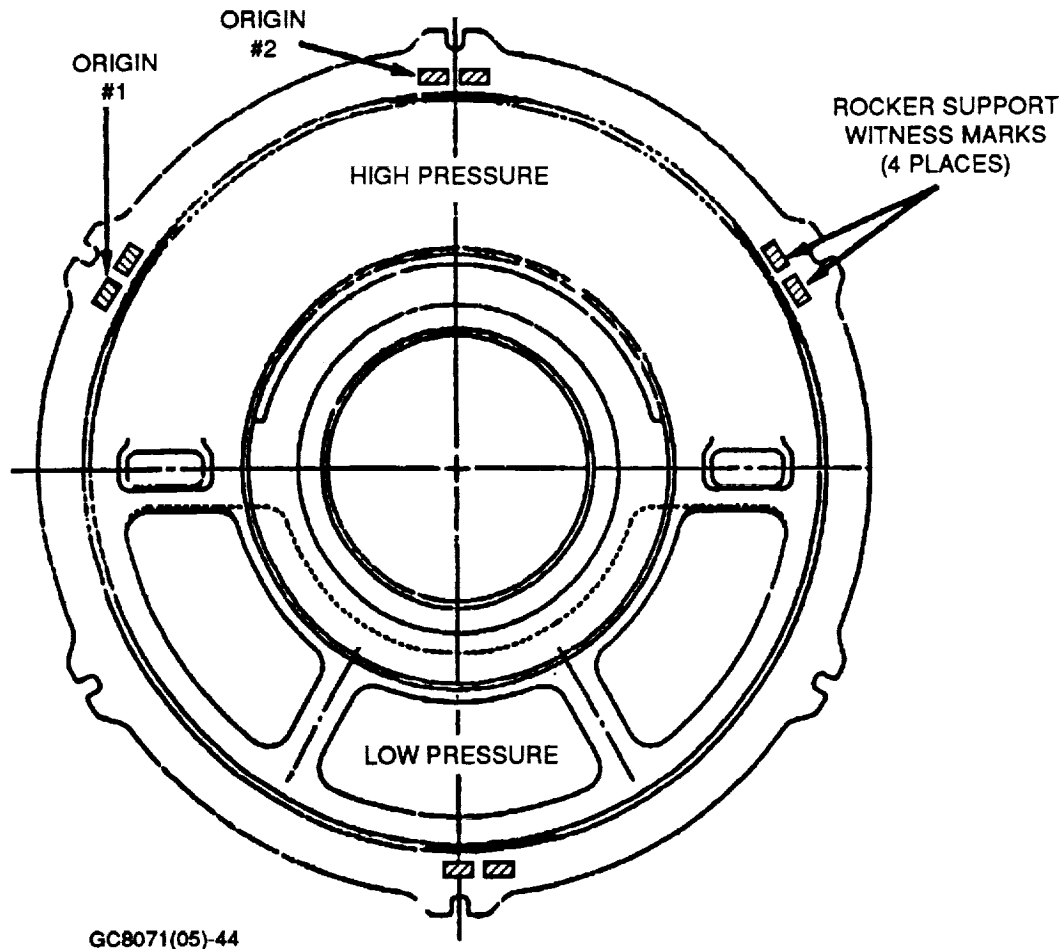
**Figure 44. Milestone 5 Flow Separator Housing Failure Origins.**

Both failures of the FSH originated at a rocker support location. However, the location of the failures were not at the same support. The locations of the failure origins and the rocker support witness marks are shown in Figure 44. Origin 1, from Build 23A, came from an internal corner of a

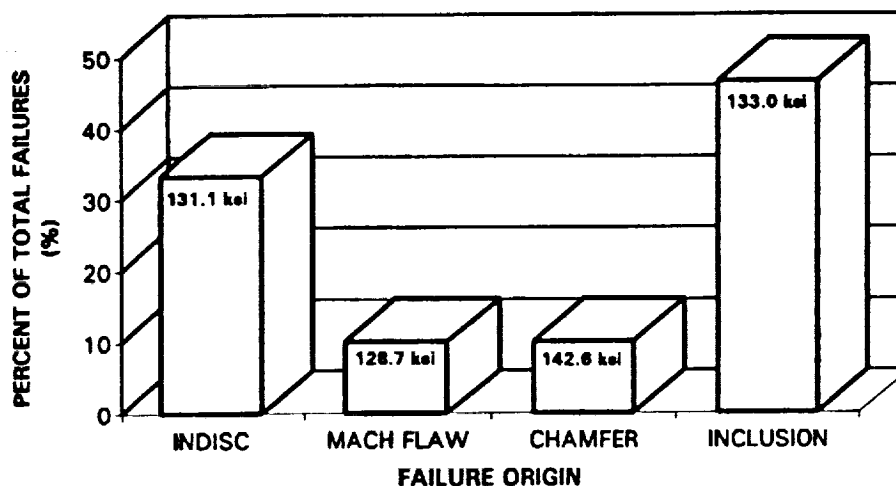
Figure 45. Fractography Results of First IRT Rotor Delivery Cut-up Test Specimens.

The properties are obviously very good, and meet the stress-rupture life and Weibull modulus targets for the GAPD ATTAP program. Fractography of specimens tested at room temperature shows that the majority of failure origins are due to inclusions (see Figure 45). SEM quantitative analysis shows the inclusions to be either carbon (suspected to be from ball mill liner material) or sintering aid agglomerates (from incomplete mixing and milling during slip preparation).

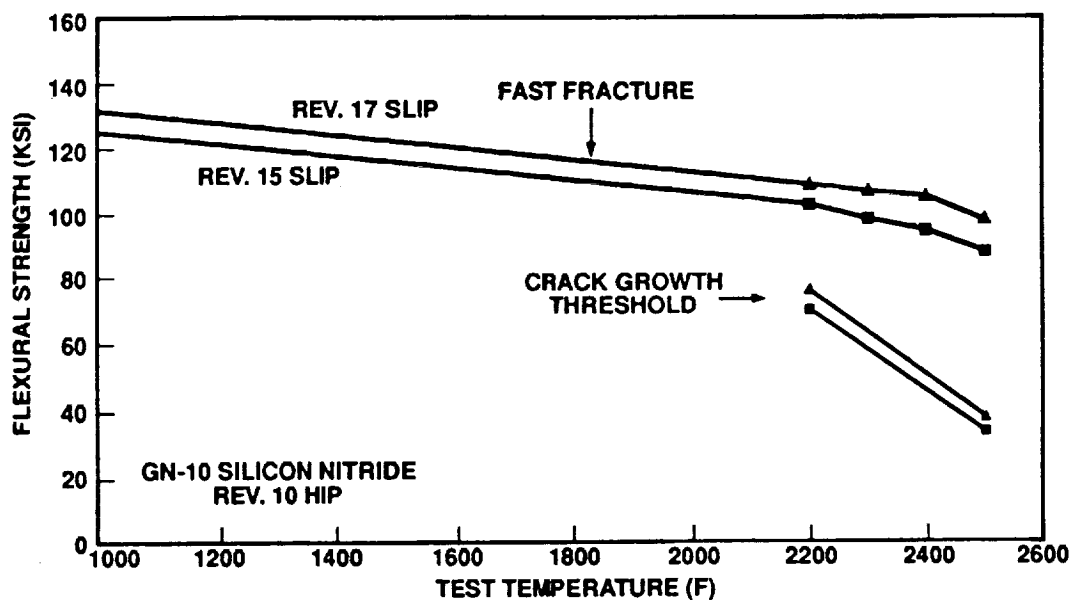
Figure 47. Comparison of Fast Fracture Strength and Slow Crack Growth Threshold for Rev. 15 and Rev. 17 GN-10 Slip.

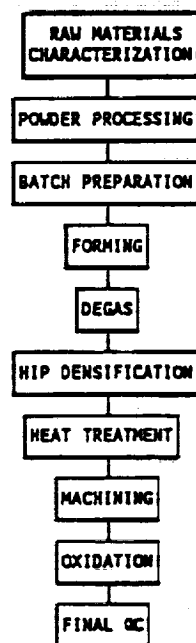
Figure 50. NT154 Process Flow Chart.

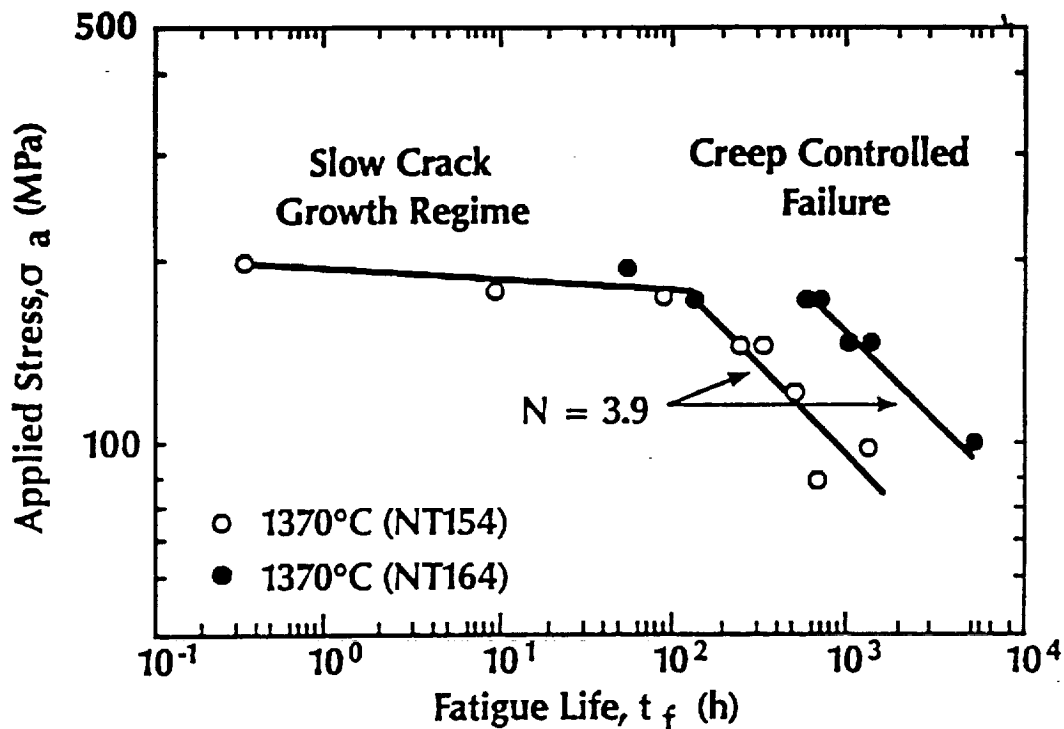
Figure 51. Creep Behavior Of NT154 And NT164  $\text{Si}_3\text{N}_4$  At 1370C.

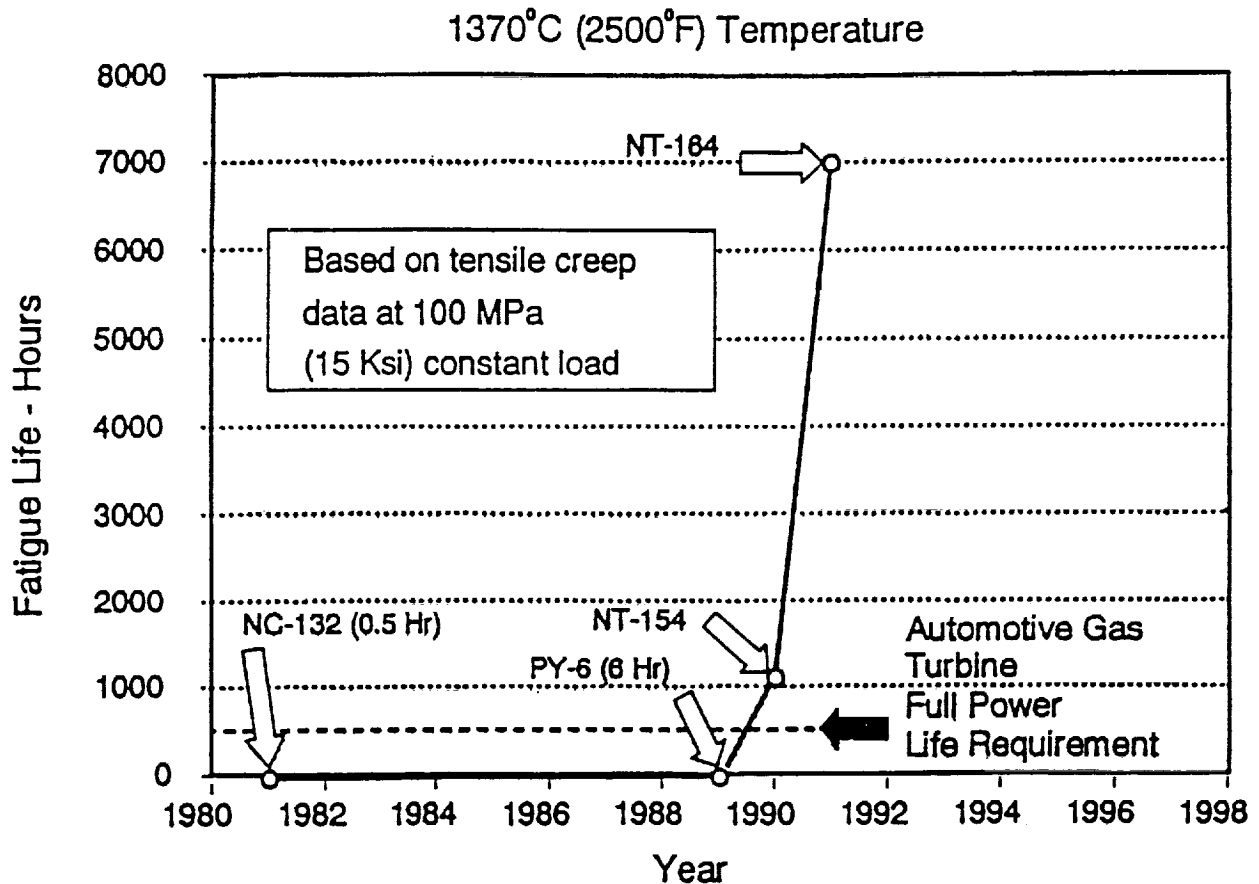
Figure 52. Fatigue Life Improvements Of  $\text{Si}_3\text{N}_4$  (ORNL Data).

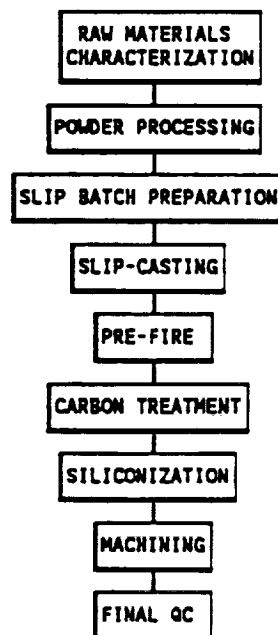
Figure 53. NT230 Process Flow Chart.

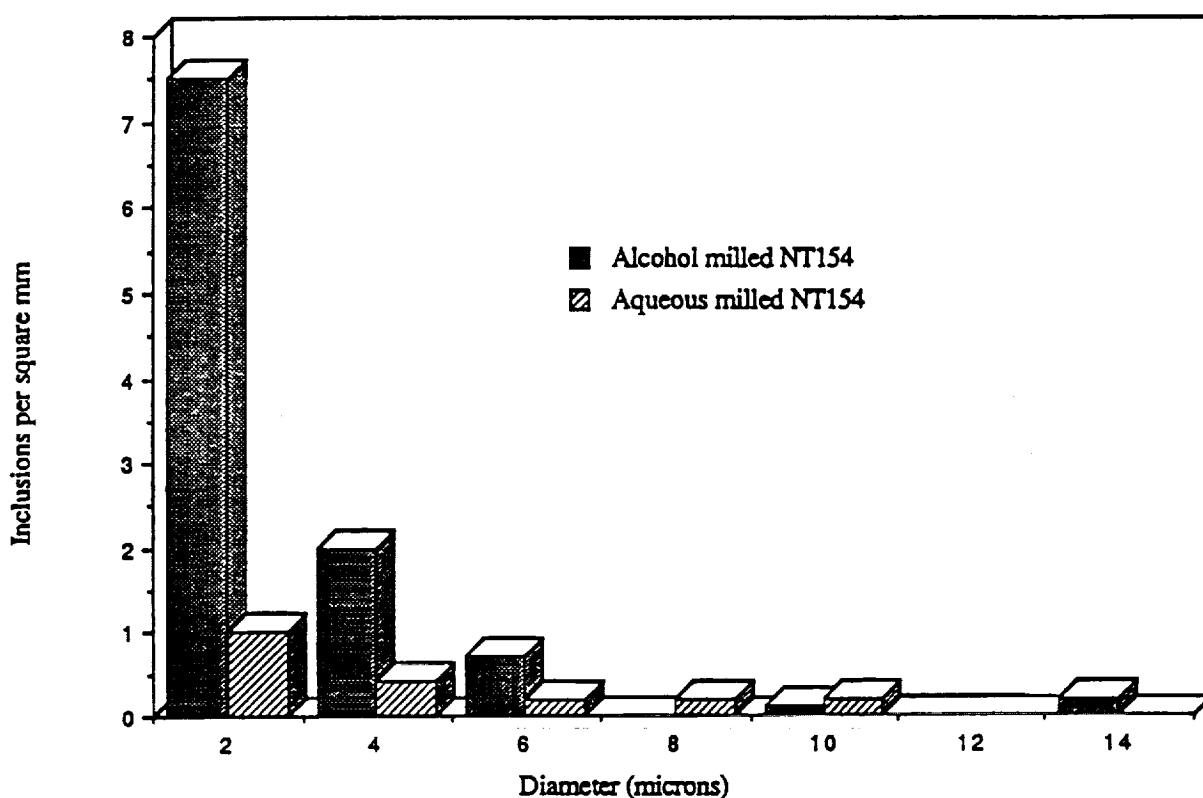
Figure 55. Inclusion Frequency Of Alcohol- Versus Aqueous-Milled NT154.
